FARMINGTON RIVER BASIN
BURLINGTON CONNECTICUT

WHIGVILLE RESERVOIR DAM
CT-00379

PHASE I INSPECTION REPORT
NATIONAL DAM INSPECTION PROGRAM

FEBRUARY 1980

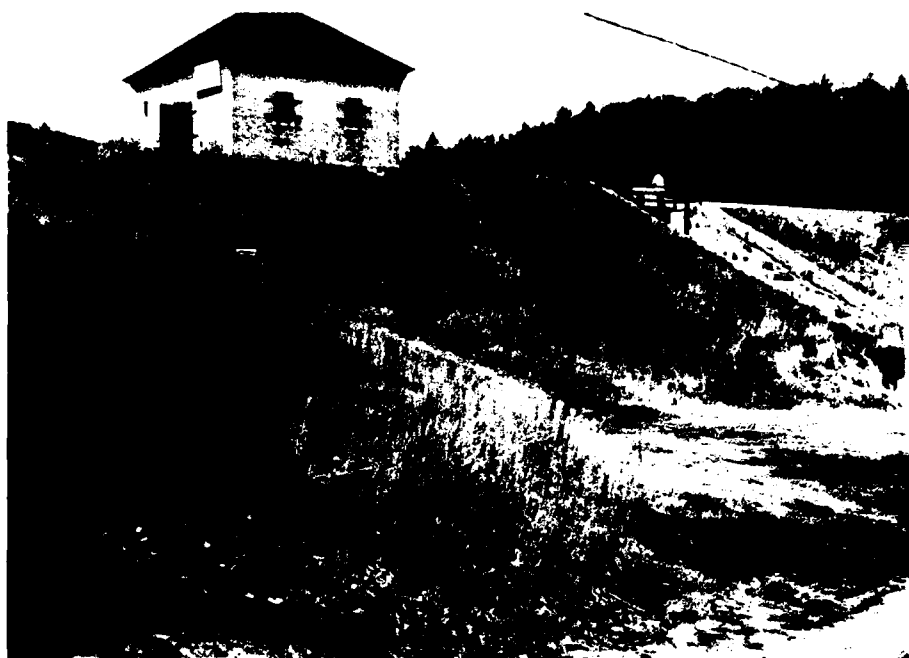
Generally the lower slope contains an extensive growth of saplings, brush and other types of vegetation as indicated in photo No. 14. The area at or just upstream of the toe of the lower slope is generally wet and soggy (photo No. 4). Standing water was observed at several locations adjacent to the spillway channel.

PHOTO #4: Downstream slope from vicinity of toe.
